Asbestos Survey Report

Site: 145 Drury Lane

Task No.: 105478

BES Project Ref: Common Areas Type 2 Survey - D&G

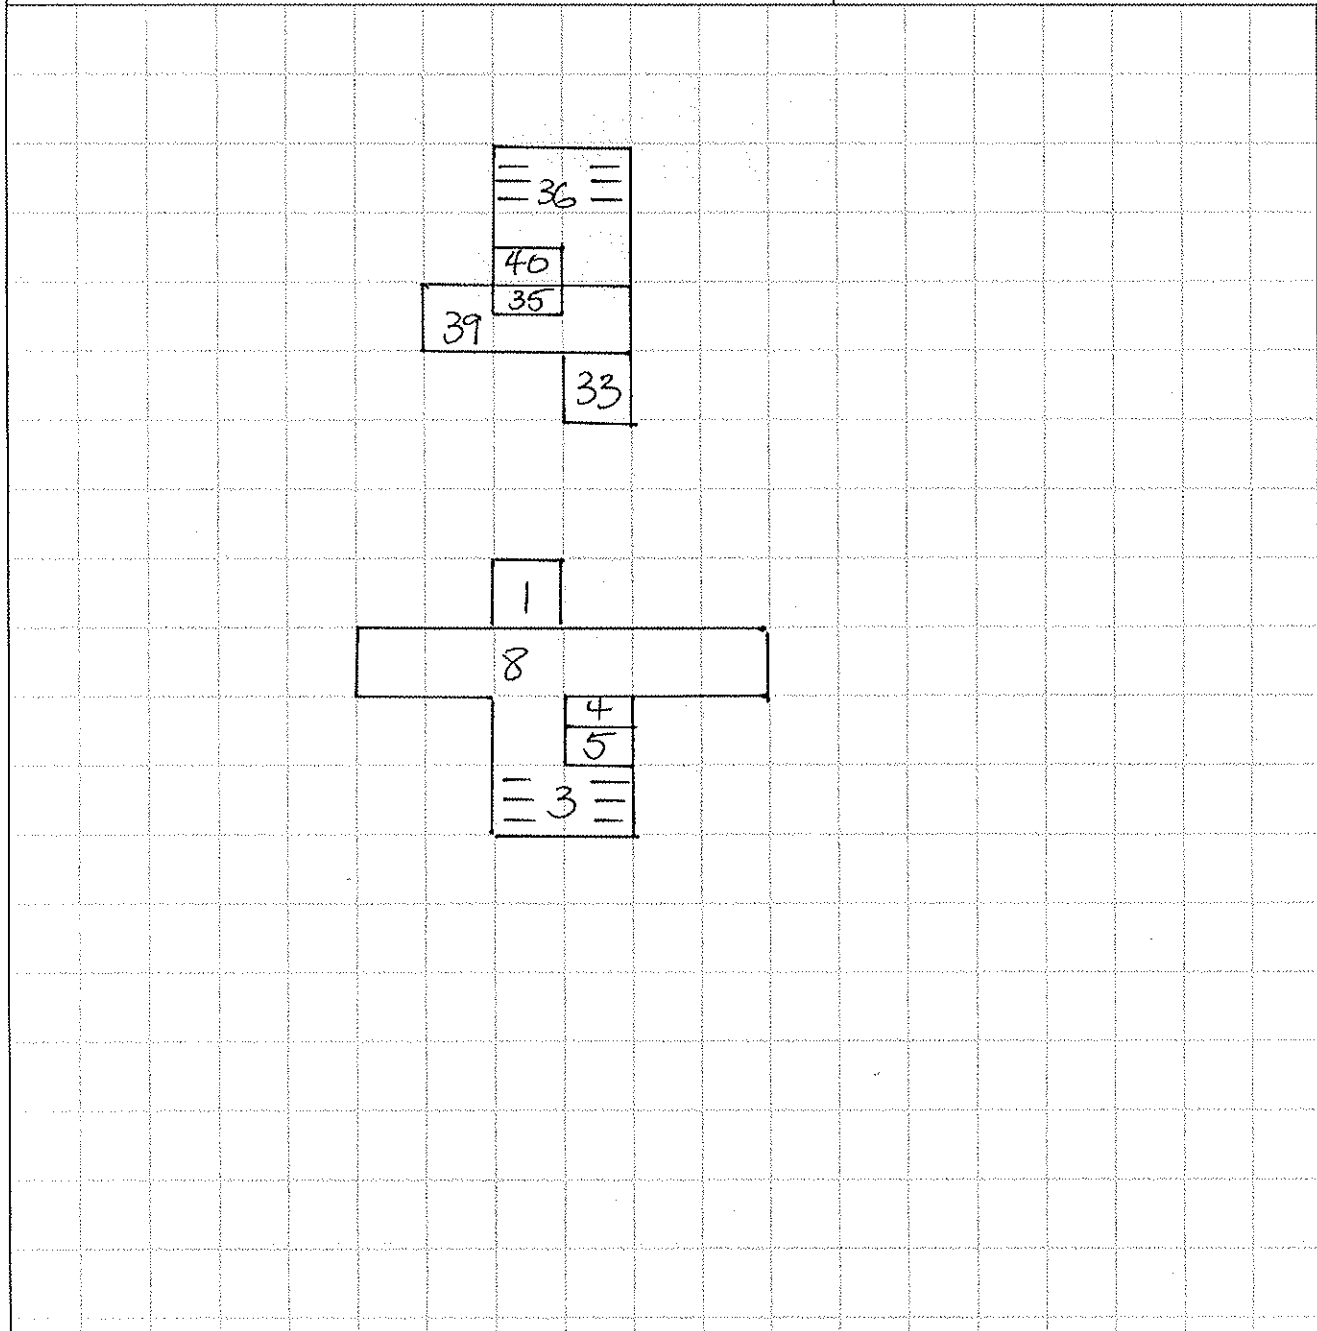
Task No.	105478	Survey Date	20 / 12 / 04	North Point
Building Name	145 DRURY LANE WC2			↓
Floor Level	FOURTH	Diagram No.	6 of 8

Fourth	Electric Riser	Debris	Insulating Board (IB)	1 m2	070/029 No Asbestos Detected	<input checked="" type="checkbox"/>	insulating board debris to floor.	+	=			<input type="checkbox"/> Floor voids <input type="checkbox"/> Floor ducts <input type="checkbox"/> Fixed ceilings <input type="checkbox"/> Fixed ceiling <input type="checkbox"/> Service ducts <input type="checkbox"/> Structural voids <input type="checkbox"/> Structural boxing <input type="checkbox"/> Plant / equipment <input type="checkbox"/> Dry lining or boxing	Type 2 105478 1213944	6 m2
Fourth	Corridor			N/Q		<input checked="" type="checkbox"/>	No suspect material seen.	+	=			<input type="checkbox"/> Floor voids <input type="checkbox"/> Floor ducts <input type="checkbox"/> Fixed ceilings <input checked="" type="checkbox"/> Fixed ceiling <input type="checkbox"/> Service ducts <input type="checkbox"/> Structural voids <input type="checkbox"/> Structural boxing <input type="checkbox"/> Plant / equipment <input checked="" type="checkbox"/> Dry lining or boxing	Type 2 105478 1213676	20 m2
