Asbestos Survey Report

Site: 145 Drury Lane

Task No.: 105478

BES Project Ref: Common Areas Type 2 Survey - D&G

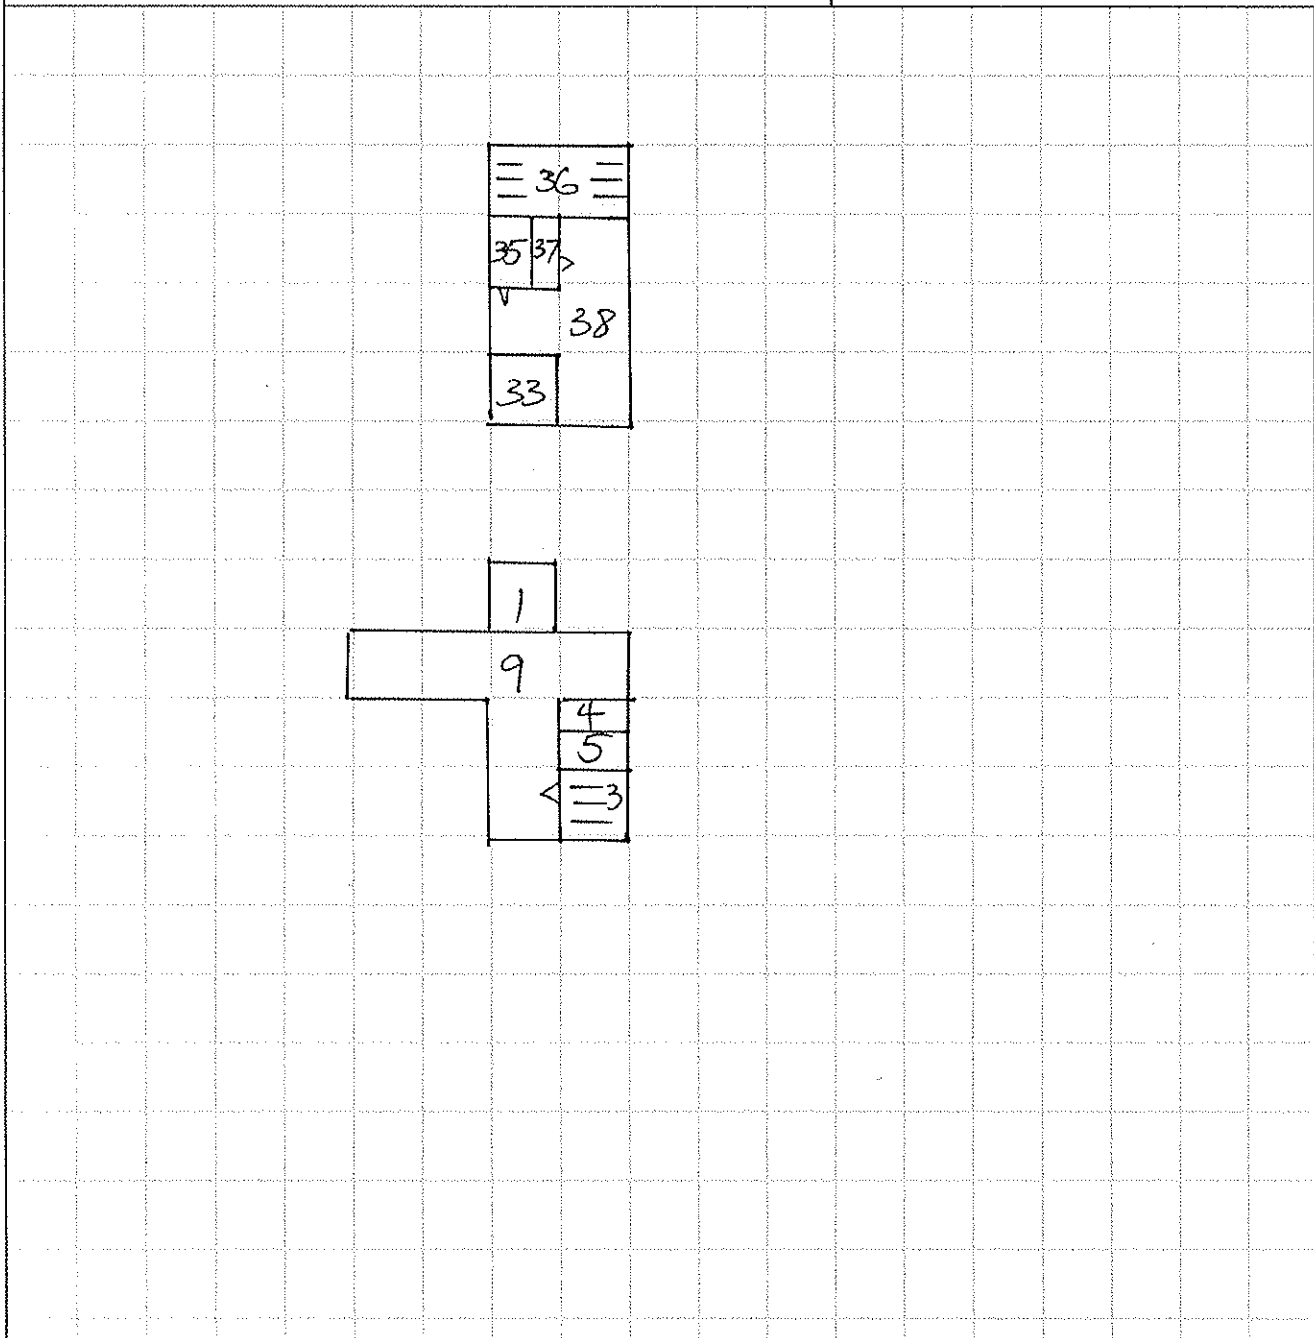
Task No.	105478	Survey Date	20/12/04	North Point
Building Name	145 DRURY LANE WC2			
Floor Level	FIFTH	Diagram No.	7 of 8	↓

For identification purposes only - Do not scale.		Roof	47	No Acc.	Externals	46
--	--	------	----	---------	-----------	----
